The Collieries of North Somerset

Shane Gould

This paper discusses the archaeology of coal mining in North Somerset. A summary of the historical evidence is given from the 3rd century AD to 1973 and the relevance of technological change is highlighted. Field archaeology for several of the more important sites is described and the influence of the industry as a factor in the development of town and countryside landscape of the area is examined. Consideration is also given to the future management and conservation of the resource.

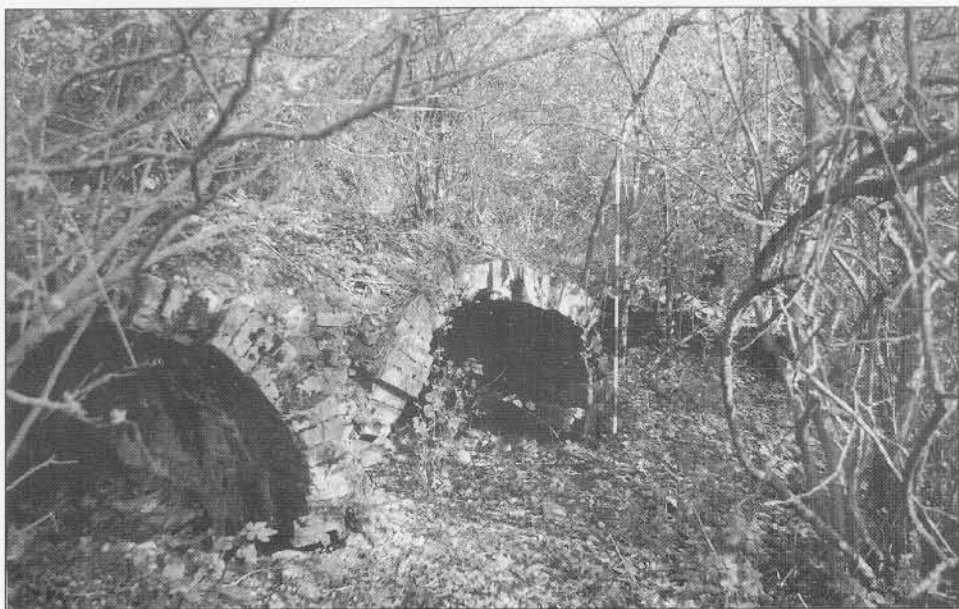
Plate 1. The nationally unique coking ovens at Vobster Breach.

To the east of the pithead stands a group of 77 coking ovens (Fig. 5. Plate 1). Coke was used to fuel the furnaces in the iron and steel industry, and came to replace charcoal in a variety of industrial processes. In England most of the surviving coke ovens are of the beehive form and all have lost their associated colliery; those at Vobster Breach are 'long' ovens and appear to be the only extant examples in Britain. The ovens were erected in two banks; a single linear rank and a double back-to-back range. They are built of refractory brick and have an arched entrance with a flue to the rear. Small or lump coal was fed into the mouth of the oven, and the heat from the previous firing was usually sufficient to ignite the charge. An iron-framed door was then lowered and the airflow entering the oven reduced and eventually stopped altogether. After two or three days the charge was drawn and allowed to cool. It was then loaded into waiting wagons and the cycle repeated.

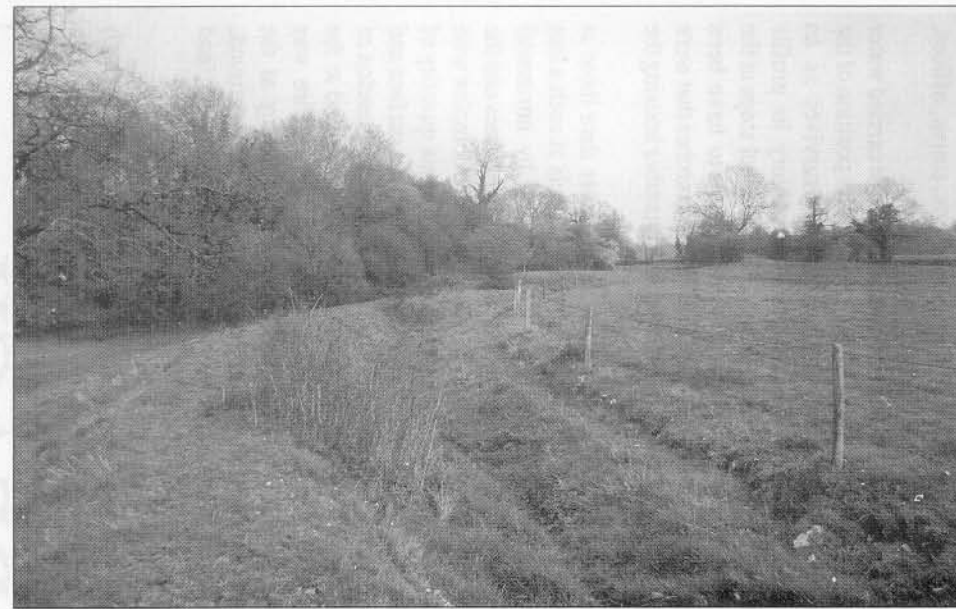
Plate 2. This earthenwork leat transported water to drive the water wheels at Vobster Colliery; the coal mine lies in the centre background of the photograph.

A leat approximately one kilometre in length carried water from the River Frome to Vobster Colliery. The position of the weir is no longer apparent, but the leat survives as an earthwork cut and as it approaches the colliery its profile becomes more pronounced (Plate 2). The channel stops at the west end of the site and water then appears to have been delivered through two (now overgrown) stone arches that were presumably connected to an underground chamber housing the waterwheels.

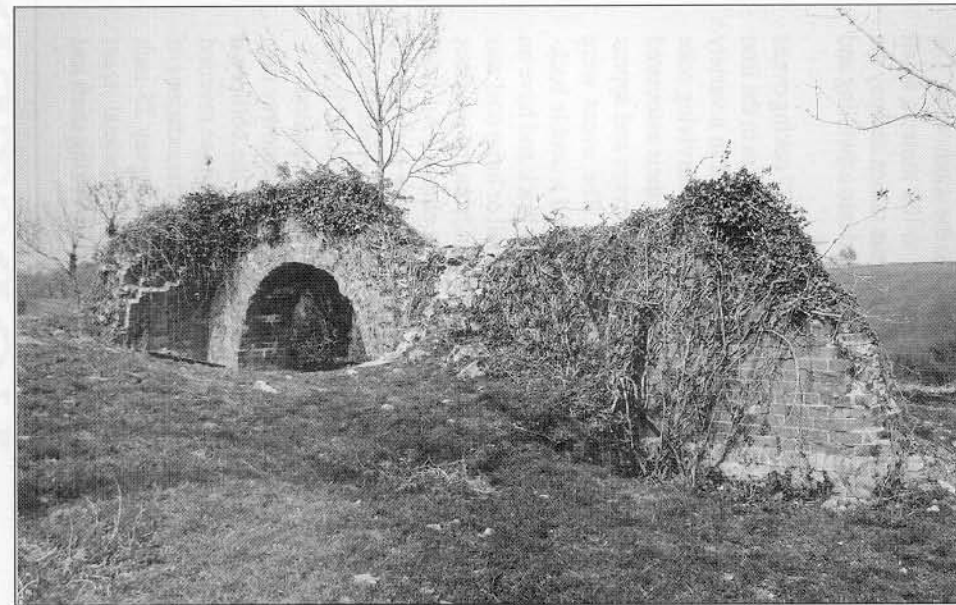
Plate 4. The Guibal fanhouse at Mackintosh replaced an earlier air furnace at the foot of the upcast shaft in the early decades of the 20th century.

In order to increase output from Newbury and comply with new legislation a second shaft was sunk at Mackintosh in 1867 (Down and Warrington 1971, 234). The shafts were connected by a steam-driven narrow-gauge tramway and the route survives as an un-metalled track. Mackintosh became the upcast shaft for the colliery with ventilation being effected by a steam driven Guibal fan. Most of the fan housing has been demolished, but the one surviving arched wall gives a fan diameter of four metres (Plate 4). A modest single-storey brick-built horizontal two cylinder winding engine house, a boiler house, chimney and a wooden headgear also stood at the pit head. The foundations for most of these features were removed when British Coal re-capped the shaft in 1995, but

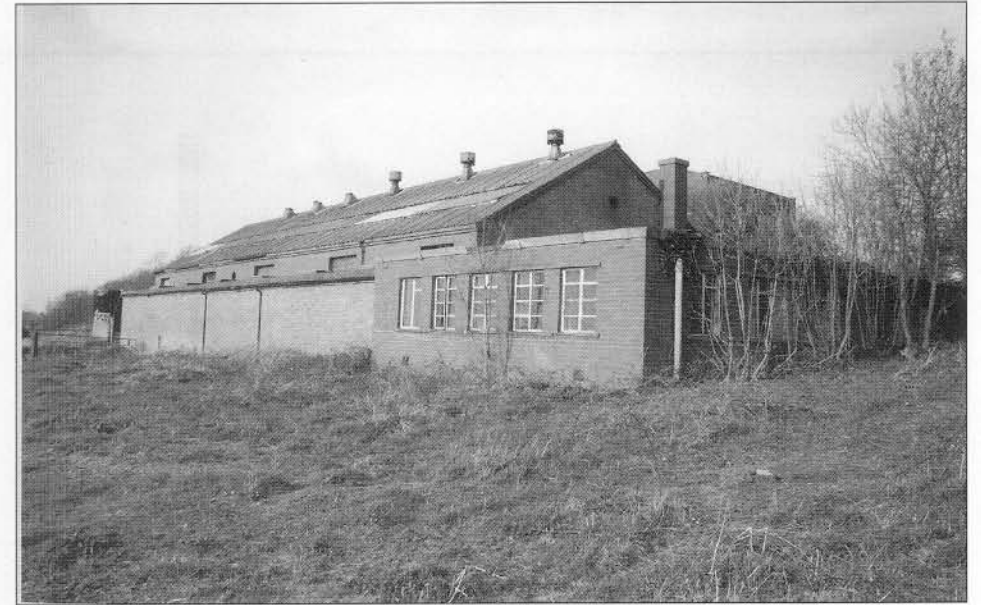
Plate 6. A now demolished 'functionalist' bath house at Pensford.

The pithead baths stood on the west side of the road and these, the first to be erected in Somerset, were completed in 1931 (Plate 6). The baths were built of red brick and had a gabled central range which contained the showers and locker rooms; the flat-roofed entrance stood to the south. They were unfortunately demolished in the early 1990s.

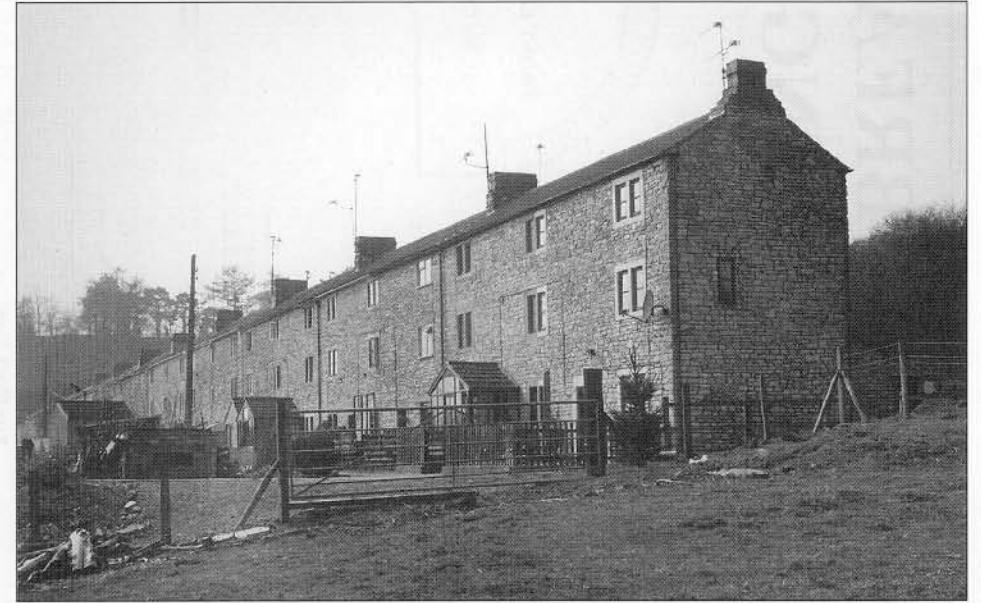
Plate 8. Whitelands Radstock. These buildings are remarkably similar to the three-storey weavers houses in Yorkshire.

At Radstock the first purpose-built miners' terraces were erected by the Waldegraves in the 1840s on land to the east of the newly opened Tynning pit. These unusual three-storey buildings formed a separate industrial community, the Whitelands, which both avoided and could not be seen by the more respectable residents within the old medieval centre (Plates 8 and 9). Further terraces were erected during the second half of the 19th century, but interestingly these were located closer to the town; Waldegrave Terrace and Waterloo Cottages stood on the northern bank of the River Cam. Social
